Clinical Application of the **Proximal Box Elevation Technique** in combination with a Cerasmart Onlay.

By **Dr. Dayana da Silva Gonçalves, Prof. María Victoria Fuentes** and **Prof. Laura Ceballos**, Spain

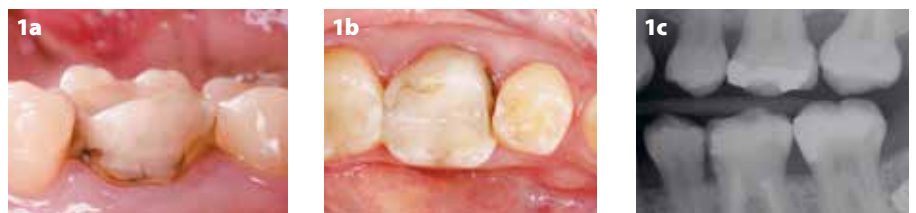
Figures 1a, 1b & 1c: Images of the lower left first molar showing a defective and extensive restoration, in a buccal view (1a), occlusal view (1b) and in the bite-wing radiograph (1c).

A 33-year-old patient arrived to the dental office complaining of food impaction because of an extensive MOD resin composite restoration in the lower left first molar. The restoration also included the mesiobuccal cusp and, in an occlusal view, marginal staining, a deficient occlusal and proximal morphology as well as the absence of a correct contact point. From a buccal view, the pigmented margins of the restoration and a fissure line in the distobuccal cusp were also evident. Finally, a radiolucent area, consistent with secondary caries was observed on the mesial cervical margin in the bite-wing radiograph (Figure 1-a, b, and c).
