Minimal invasive rehabilitation of generalized tooth wear using a conventional composite and the stamp technique.

By Prof. Dr. Marleen Peumans, Belgium

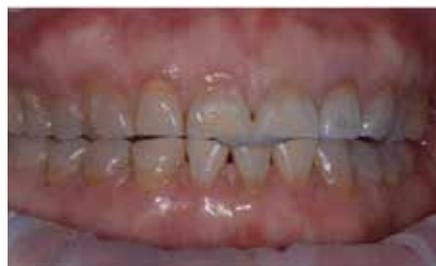
Fig. 5: The bite registration was done in (a so-called) centric relation using an anterior composite jig.

precise planning. The bite registration was performed in (a so-called) centric relation using a composite anterior jig (**Fig. 5**). This jig allowed for deprogramming of the masticatory muscles and guided the mandible into a passively retruded position.³ The vertical dimension of occlusion was increased using this jig, with the final VDO determined by the

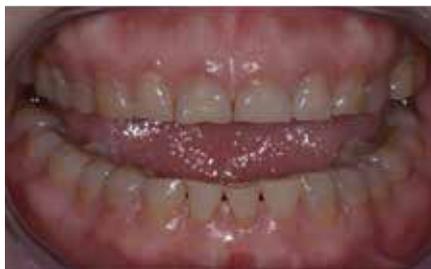
Fig. 2: Intraoral view before treatment, showing signs of generalized severe tooth wear.

Upon clinical examination, the patient presented with extensive wear across the dentition, most notably on the anterior teeth (**Figs. 2-4**). The wear pattern was consistent with attrition², and the patient confirmed a long-standing habit of bruxism. She had been wearing a night guard for several years, indicating awareness and management of her parafunctional behaviour.

In the lower jaw, agenesis of one central incisor was noted, and several posterior teeth exhibited fractured cusps. The severity of wear necessitated a comprehensive approach to restore both the vertical dimension of occlusion (VDO) and the structural integrity of the teeth.

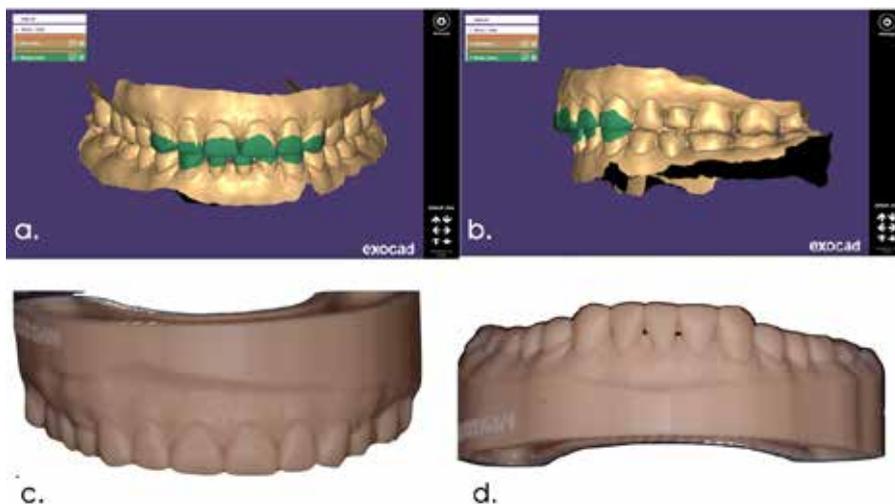
Fig. 6: a and b: Digital wax-up of the upper and lower anterior teeth in the desired vertical dimension of occlusion. c and d: After approval of the digital wax-up on the viewer, 3D printed models were made of the upper and lower jaw.

The dental technician created a digital wax-up of the upper and lower anterior teeth at the newly established VDO (**Fig. 6a-b**). This wax-up was reviewed and approved using a digital viewer (**Fig. 6c-d**), after which 3D-printed models were fabricated to

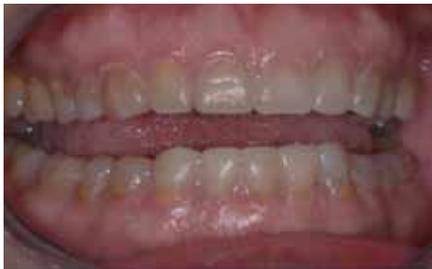
Fig. 7: Mock-up from a dual-cure bisacrylic composite resin (Tempsmart DC, GC).

A hard silicone key was fabricated based on the 3D-printed model, and a mock-up of the anterior teeth (**Fig. 7**) was made using a dual-cure, bisacrylic composite (Tempsmart DC, GC). This

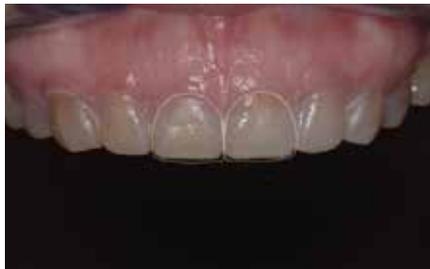
Fig. 8: Mock-up of the upper anterior teeth. Instructions were given to the dental technician to make the upper central incisors slightly longer (dotted white line).

step allowed both the clinician and the patient to visualize the proposed changes in tooth length, incisal line, and overall smile aesthetics. Following evaluation, minor adjustments were requested, including a slight increase in the length of the upper central incisors, which was communicated to the dental technician (**Fig. 8**).

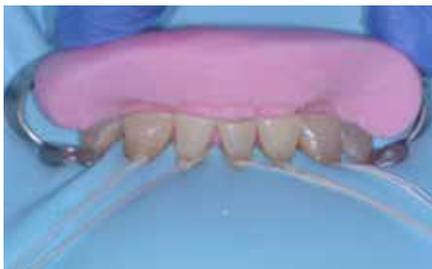
Fig. 9: Isolation of the lower anterior teeth with the palato-incisal silicone key in position.

The lower anterior sextant was isolated with rubber dam, and the palato-incisal silicone key was tested for fit (**Fig. 9**). No dental preparation was done, except for smoothing sharp enamel margins with a microfine diamond bur and sandblasting of the bonding surfaces with 50 µm alumina powder at a pressure of 4 bar to clean the tooth and remove amorphous enamel, exposing the prismatic structure for improved adhesion.⁴

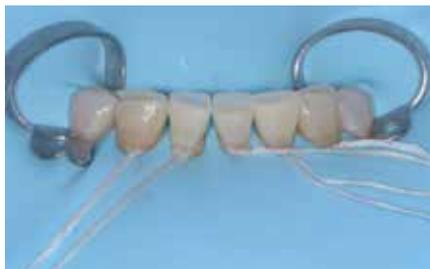
Fig. 10: The palatal enamel walls of the lower anterior teeth built up with Essentia DE.

The palatal enamel walls were built up using Essentia DE with the aid of the silicone key (**Fig. 10**). The dentin was restored with Essentia MD, and the teeth were completed with a buccal enamel layer using Essentia DE. The restorations were refined and completed using a microfine pointed diamond bur, polishing rubbers, composite finishing discs, metal strips and composite finishing strips to achieve a natural appearance and smooth surface (**Fig. 11**).

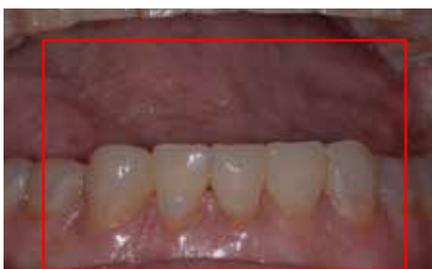
Fig. 11: Result after restoring the lower incisors with Essentia MD and DE.

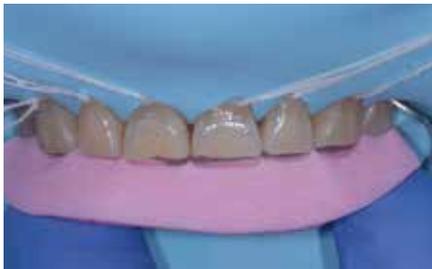
Fig. 13: The fit of the palato-incisal silicone key made is checked.

After confirming the fit of the key (**Fig. 13**), tooth preparation was carried out by removing sharp enamel margins and air abrading adjacent enamel surfaces. Small Class III cavities were prepared on both central incisors due to carious lesions (**Fig. 14**). Note that deeper, interproximal lesions need to be restored prior to using a moulding technique to avoid voids and bubbles.

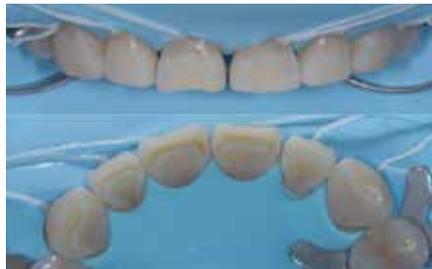
Fig. 14: Upper anterior teeth after air abrasion of the bonding surfaces. Note the small Class-3 cavities on both centrals because of caries lesions.

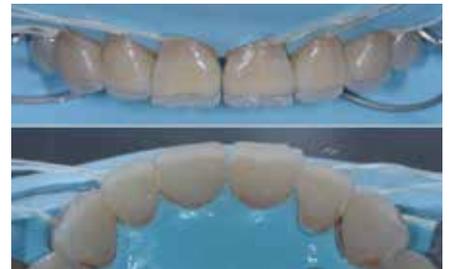
Fig. 15: After build-up of the palatal enamel wall of all upper anteriors using Essentia DE.

The palatal enamel wall was built using Essentia DE and the silicone key (partial stamp technique) (**Fig. 15**). The rest of the teeth was built up using a freehand technique. Teeth were separated with

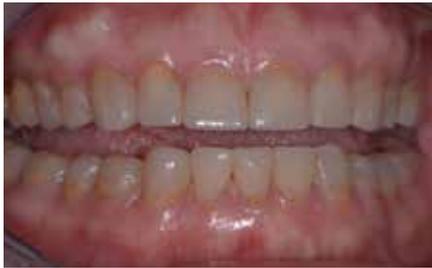
Fig. 16: Restored upper and lower anterior teeth.

clear Mylar strips, and wedges were used in interproximal spaces where needed. The dentin was restored with Essentia MD, followed by buccal enamel layering with Essentia DE. The restorations were finished and polished to match the lower anterior teeth and establish a harmonious anterior guidance (**Fig. 16**). After restoration, occlusal contacts were evenly distributed across the anterior dentition (**Fig. 17**).

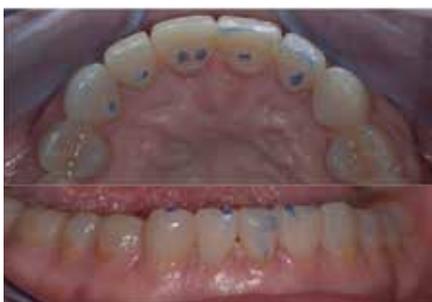
Fig. 17: Occlusal contacts after restoring the anterior teeth.

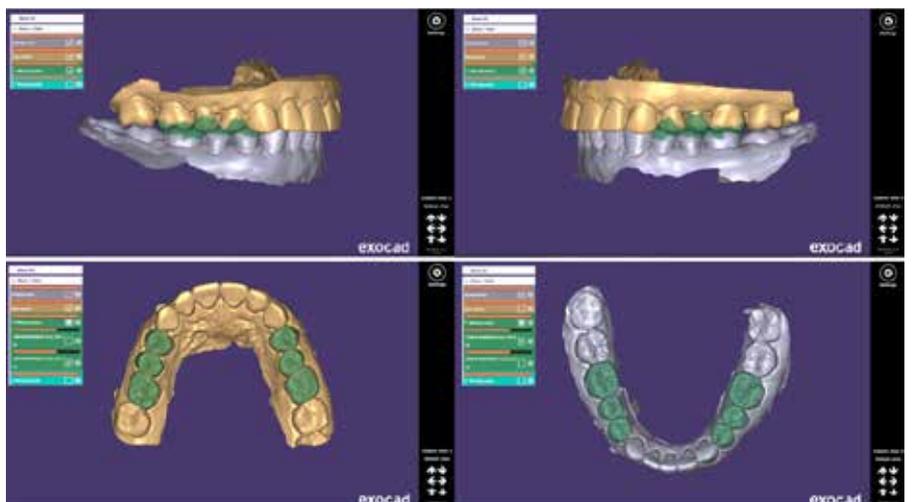
Fig. 18: Digital wax-up of premolars and molars, excluding the second premolar that was kept as a reference point.

The wax-up was designed to replicate the anatomy of the planned direct composite restorations, with careful attention to the delineation of occlusal marginal ridges. The wax-up excluded the second molars, which served as reference points for repositioning the silicone keys during restoration, together with the restored canines (**Fig. 18**).

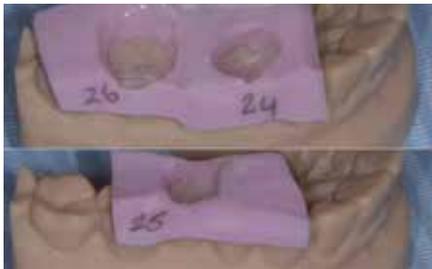
Fig. 19: Hard silicone keys relined with Exaclear (GC) used to transfer the morphology of the 3D-printed model into the mouth of the patient.

Hard silicone keys were made and the occlusal area of the teeth to be restored was cut out and relined with EXACLEAR. These were used to transfer the wax-up to the patient's mouth (**Fig. 19**). An alternative and more precise way to make a transparent rigid key is to rebase a vacuum-formed impression tray

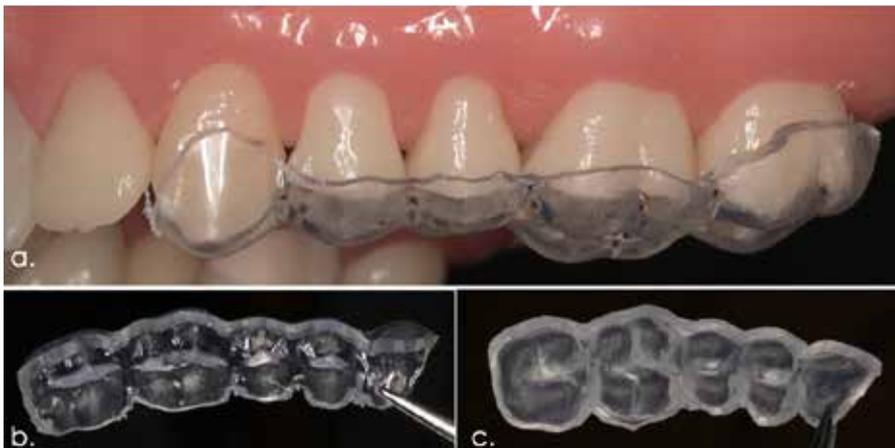
Fig. 20: Alternative stamp technique with vacuum-formed impression tray (2mm thickness) relined with EXACLEAR.

(hard resin plate with a thickness of 2 mm) with EXACLEAR. This tray is cut 1.5-2mm further than the margins of the worn teeth and sandblasted prior to the rebasing (**Fig. 20**).

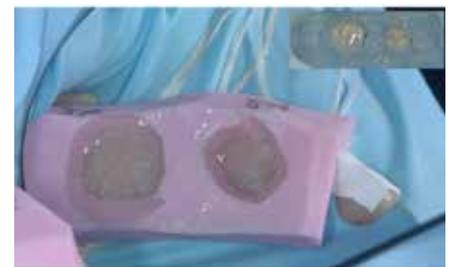
Fig. 21: The keys were filled with composite resin (Essentia DE) and seated.

Restoration began with teeth 24 and 26 (**Fig. 21**), followed by tooth 25. Neighbouring teeth were protected with metal strips during etching with phosphoric acid, rinsing and

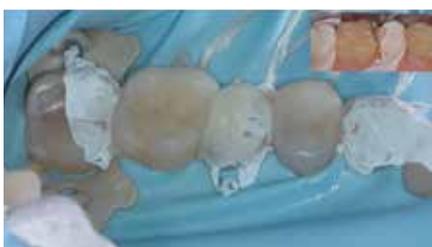
Fig. 22: After removal of the silicone key, each restored tooth was light-cured for an additional 20 seconds. Excess cured composite extending onto adjacent teeth was carefully trimmed.

40 seconds, followed by a second curing phase after removal of the key (**Fig. 22**). The excess cured composite that ran over the occlusal surface of the neighbouring teeth was removed with a scalpel (n°12) (**Fig. 23**). After interproximal finishing, tooth 25 was restored using the same protocol; tooth 27 was built up with free-hand modellation.

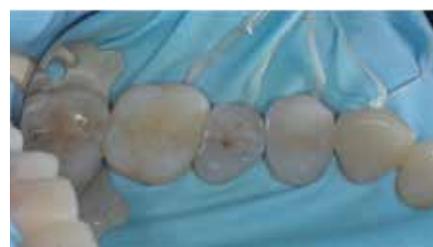
Fig. 23: After finishing composite restorations on teeth 26 and 24 and before restoring tooth 25.

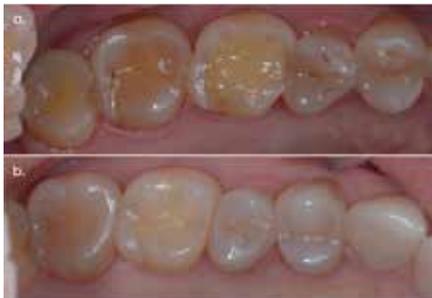
Fig. 24: Second quadrant before (top) and after (bottom) treatment. The second upper molar (tooth 27) was restored using a freehand technique.

Final polishing was completed with Identiflex composite polishers (Kerr) and a nylon brush to enhance gloss (**Fig. 24**).

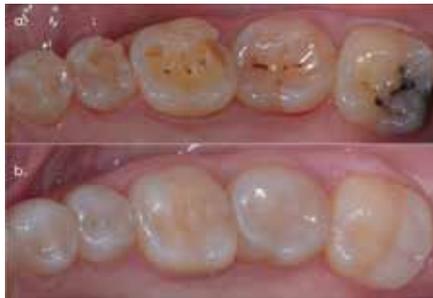
Fig. 25: Third quadrant before (top) and after (bottom) treatment

The same restorative protocol was applied to quadrant 3, including composite build-ups on teeth 34 and 36 using the silicone key (**Fig. 25**). The second and third molars were restored using freehand modelling techniques. The first and fourth quadrant were restored in the same manner in the following session (**Figs. 26-27**).

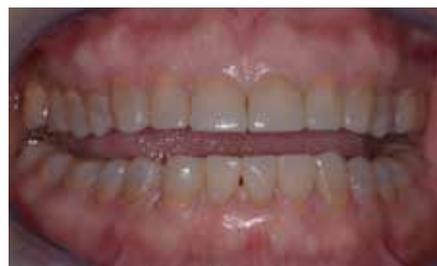
Fig. 28: Result after final finishing and polishing. The old Class-5 composite restorations on the upper premolars/molars still need to be replaced.

After final finishing and polishing, the restorations exhibited excellent anatomical form and surface texture. The old Class V restorations on the upper premolars and molars were noted for future replacement.

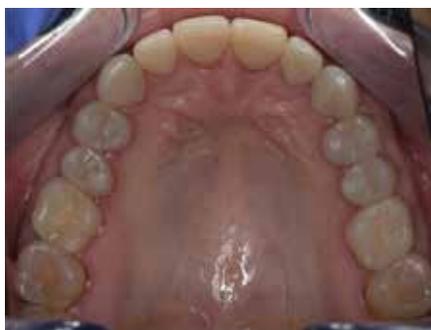
Fig. 32: Follow-up after 3 years- occlusal view upper jaw. Slight wear of the composite restorations can be noticed.

Three years post-treatment, the restorations demonstrate stable clinical performance with no signs of failure. The overall condition of the restorations remains satisfactory, indicating good long-term durability. Minor wear could be seen on the composite surfaces, which is consistent with normal functional use over time (**Figs. 31-33**).
