Implant Literature Compendium

GC Tech.Europe

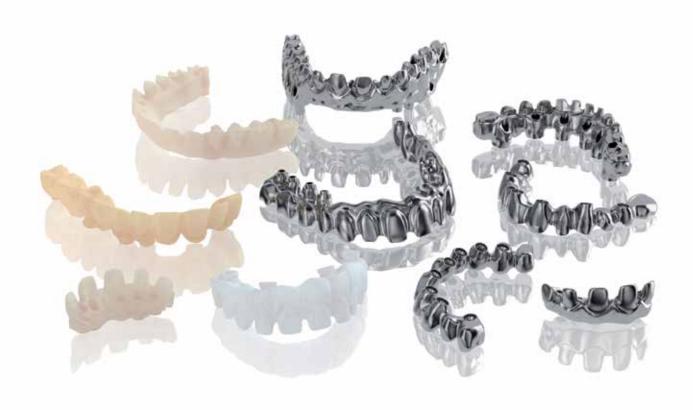
Full arch implant rehabilitation: a case report

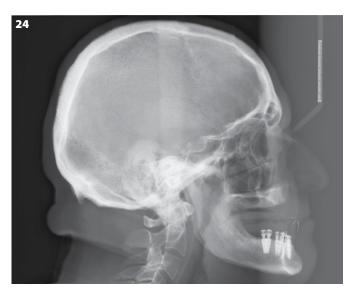
Fig. 23: Lead foil on the old denture for X-ray evaluation.

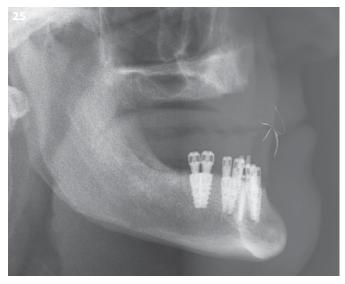
Fig. 25: Close up. Lateral X-ray.

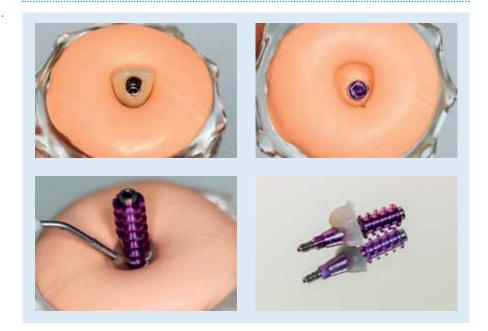
Figure 18 a-d. Preparation of an individualised impression post copying subgingival part of the provisional.

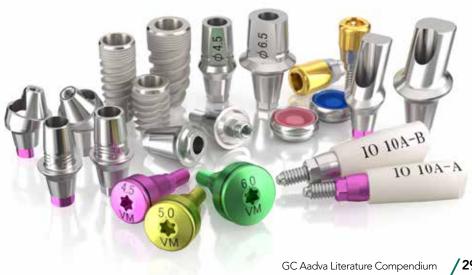
Implant shape and immediate loading: the Aadva solutions.

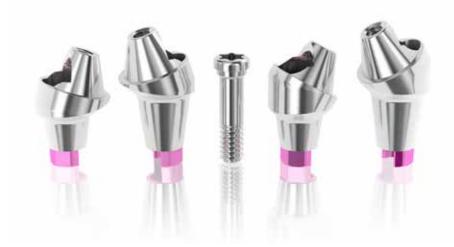
The following day, as requested by the patient, a reinforced resin prosthesis without a pink resin part (Figures 19 and 20) with a correct prosthetic emergency for conditioning the tissues in the healing phase (Figures 21, 22 and 23) was delivered. The screws were tightened to 15 Newton and the access holes were temporarily sealed with impression silicone to facilitate removal of the prosthesis, if required during followup. The final radiograph showed a correct fit of the prosthesis on the SR prosthetic abutments (Figure 24).
